ARTICLE

Radosław Hofman

ANALYSIS OF THE POSSIBILITY OF AN INCORRECT SHIFT OF THE MECHANICAL INDEX OF A DIAPHRAGM GAS METER WORKING UNDER VIBRATION

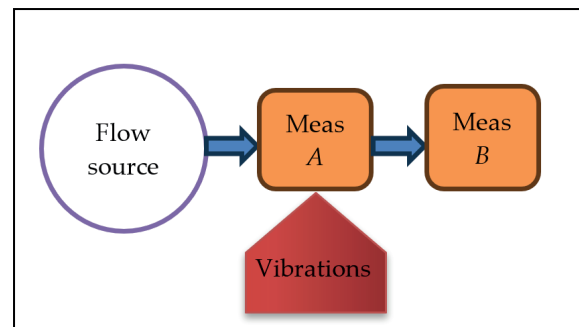
Fig. 1. Measurement schema

The compressed air was to flow first through gas meter A, subjected to vibrations, and then be pumped directly from it to gas meter B – identical and operating under normal conditions. In this way, the risk of leakage in the measuring system was eliminated (if it occurred, significantly lower readings would be obtained on gas meter A than on B with the vibration generator switched off) and the system was theoretically ensured to operate synchronously. Since the scope of the study was limited, it was assumed that any difference in the operation of both systems was to be measured in the absence of vibrations, and then it was expected that this difference would be constant despite the activation of the vibration generator. Ultimately, it would be necessary to consider carrying out these studies with a larger number of meters and a stable source of pumping air, however, the aim of the experiment was only to determine whether vibrations affect the operation of the gas meter or not, hence the precise effect of vibrations on the measurement value was not of fundamental importance.

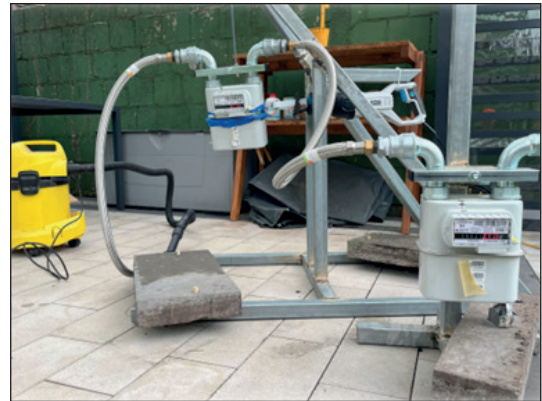
Several vibration generating systems were assembled – using an exercise mat type generator (generating vibrations in two planes with a frequency of up to 50 Hz) and an electric saw (generating vibrations in one plane with a frequency of up to 50 Hz). It turned out that the strength of the test set itself was a rather complex issue, because at a given vibration frequency and mass inertia of the gas meter, very high stresses were obtained on the vibration transfer system. The physical implementation of the measuring system is shown in Figures 2 and 3, and the measurement results are in Table 1.

Fig. 3. Physical implementation of the measurement system based on an electric saw (1D vibration)

The measurement results indicate that meter *B* measured 2.39% more gas volume than meter *A* in the test without vibrations – this is surprising in itself, because this meter was connected in serial connection after meter *A*, and therefore it was to be expected that the measurement on this meter would be rather smaller (due to possible leaks). This may indicate a difference between the meters themselves, which, although purchased from the manufacturer's distribution network, were nevertheless delivered in a way that did not protect them from vibrations during transport. However, since the measurement difference in this direction could not have resulted from a leak in the system, it was decided to continue the study (Fig. 3, 4).

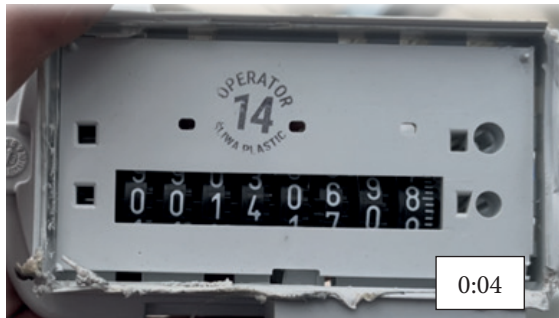
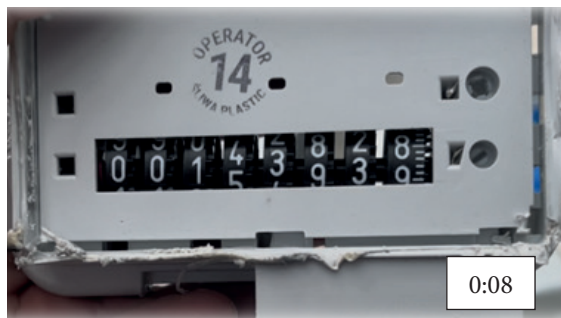
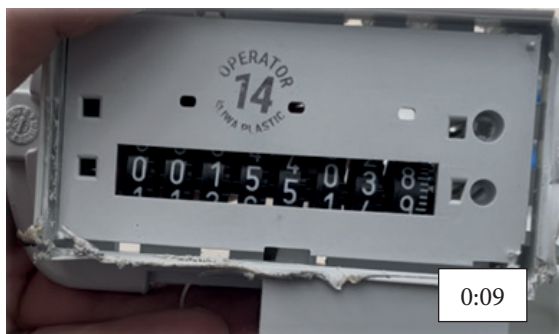
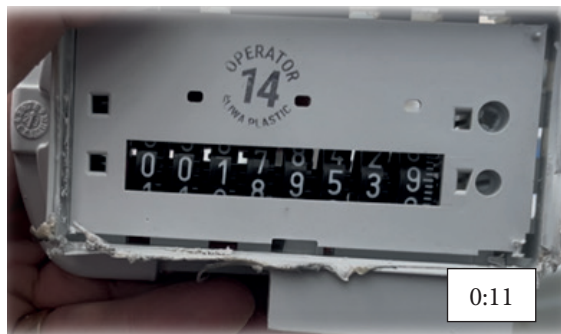
The dismantling of the abacus was done in a non-standard way – it was decided to cut out the abacus glass and cut the fasteners using an angle grinder to ensure that the abacus could be removed without any shifting that could change its condition during dismantling (Fig. 5).

Immediately after cutting off the abacus, the phenomenon that we tried to demonstrate was observed, namely – almost all of the abacus drums could be

turned freely. The protection in the form of decade flip-flops did not hinder this rotation in any way. After a preliminary analysis of the phenomenon, it was recorded on film.

Fig. 5. Selected frames of a film showing the free rotation of the abacus drums

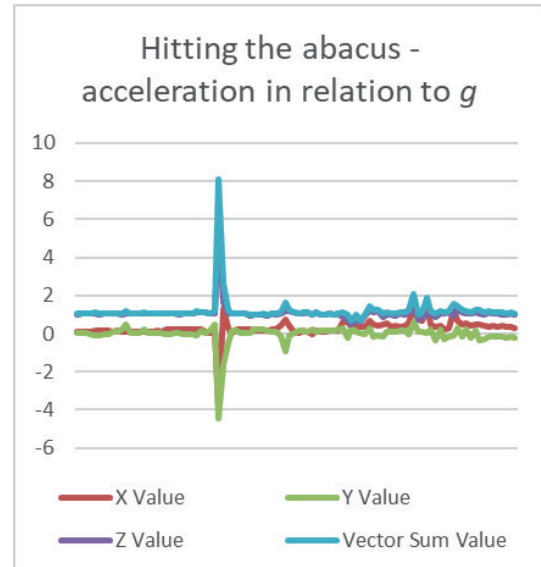
An acceleration of around 8 g may seem large, but it is an acceleration of impact. Comparable experiments were performed and a pen falling from a height of about 60 cm caused an acceleration of around 6 g to be recorded. It should also be remembered that when a vibrating cylinder is working, at a frequency of 50 Hz and a forc-

ing of 2 mm, the acceleration is 24 g. The author therefore considers that an instantaneous acceleration at the moment of impact of around 8 g indicates a rather small force of impact (Fig. 8).

Fig. 8. Acceleration value at the moment of impact – readings every 50 ms

Using Newton's second law of dynamics and assuming that the drum pin weighs 2 g, an acceleration of 8 g is obtained with a force of $F = 0.14$ N. This force is sufficient to extend the pin by about 0.5 mm. This is a surprisingly small value – it is a force comparable to the force of gravity acting on an AAA battery.

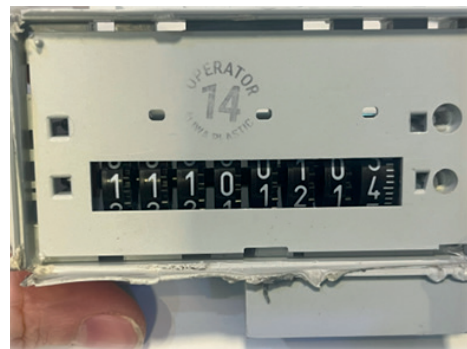
Fig. 14. Indication of the abacus at the beginning of the test

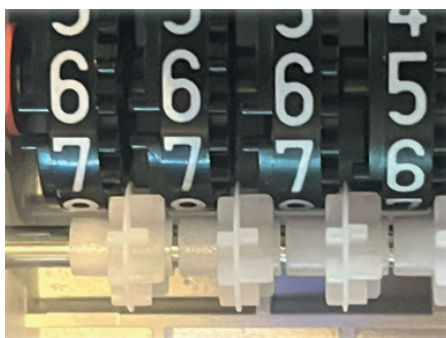
Fig. 15. Correct arrangement of the teeth of the decade flip-flops on the drums

It is obvious that the probability of the drums spontaneously moving apart and the wider tooth of the decade flip-flop falling between these drums is negligible. However, taking into account the long time horizon (vibrations lasting for weeks), this probability increases. Importantly, it was possible to demonstrate that the abacus jump is possible. Due to the manufacturer's designed drum clearances and the dimensions of the teeth, at the moment of the drums moving apart there is still 0.3 mm of reserve, and therefore the tooth of the decade flip-flop can fit in the space between the drums and move the "older" drum without using additional force. Importantly, the abacus jump does not leave any mechanical traces on the drums and decade flip-flops (Fig. 15–19).

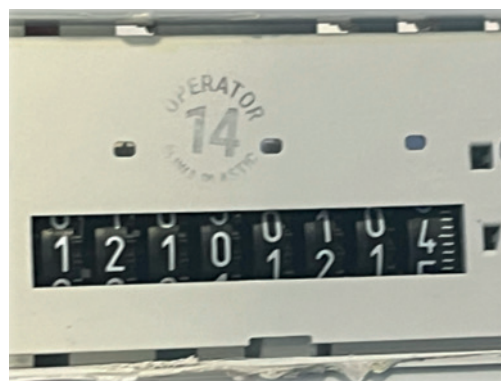
Fig. 19. New indication of the abacus

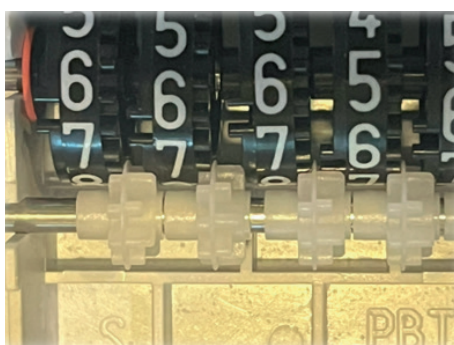
Fig. 16. Possibility of the slip-up of the wider tooth of the decade flip-flop into the space between the drums

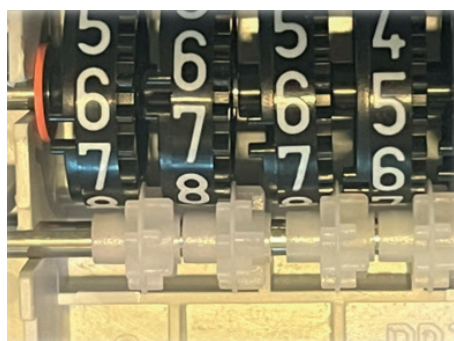
Fig. 17. Wider tooth of the decade flip-flop inserted between drums during rotation

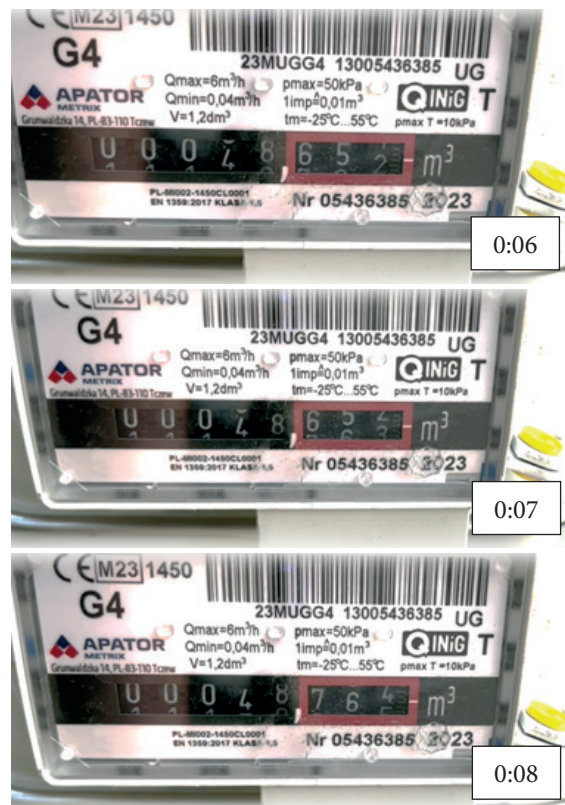
A film was then recorded to show how the gas meter works. The film shows that the drums move

almost simultaneously, so the counter jumps. This gas meter was not disassembled to leave it in a faulty state, despite having the original seals, but taking into account the description of the causes of the phenomenon in the previous chapters, it should be expected that there are no traces of jumps on the drums and decade flip-flops because they work in conditions of no pressure between these elements (Fig. 21).

Fig. 21. Selected frames showing the counter jumping in a sealed gas meter

It should also be added that manufacturers of meters can protect them from the effects described in this article. Firstly, by installing an element that prevents the shaft on which the drums are located from moving. Such an element can be installed after the counter is mounted (with a latch), or by extending the

elements securing the counter glass. Secondly, it is necessary to ensure that the drums are spread apart, even with the use of a small force, less than the wider tooth of the decade flip-flop. This can be achieved by mounting the drums on rolling bearings, for example (the current mounting method resembles a sliding bearing, hence the need to provide clearances). And thirdly – after making these modifications, full certification tests must be carried out to allow the meters to operate in vibration conditions.
