## A study of the resistance of sucker rods to fatigue failure

*The article presents the results of laboratory tests on the fatigue of samples made from full-scale sucker rods of 15H2GMF steel in various corrosive environments. For comparison, similar tests were carried out on corrosion fatigue of samples made from full-scale sucker rods of steels 20N2M, 15H2NMF and 15N3MA. The limited endurance limit of the tested rods of 15H2GMF steel in formation water is 22% lower than that of 20N2M steel and 13% lower than that of 15H2NMF steel, and in an environment simulating the action of  $H_2S$  it is 34% lower than that of 20N2M steel and 32% lower than that of steel 15H2NMF. The results were obtained using a complex surface method of strengthening sucker rods, which was developed in the laboratory of the Department of Oil and Gas Machines and Equipment of the Ivano-Frankivsk National Technical University of Oil and Gas and tested at the NGVU “Dolynanaftogaz”.*

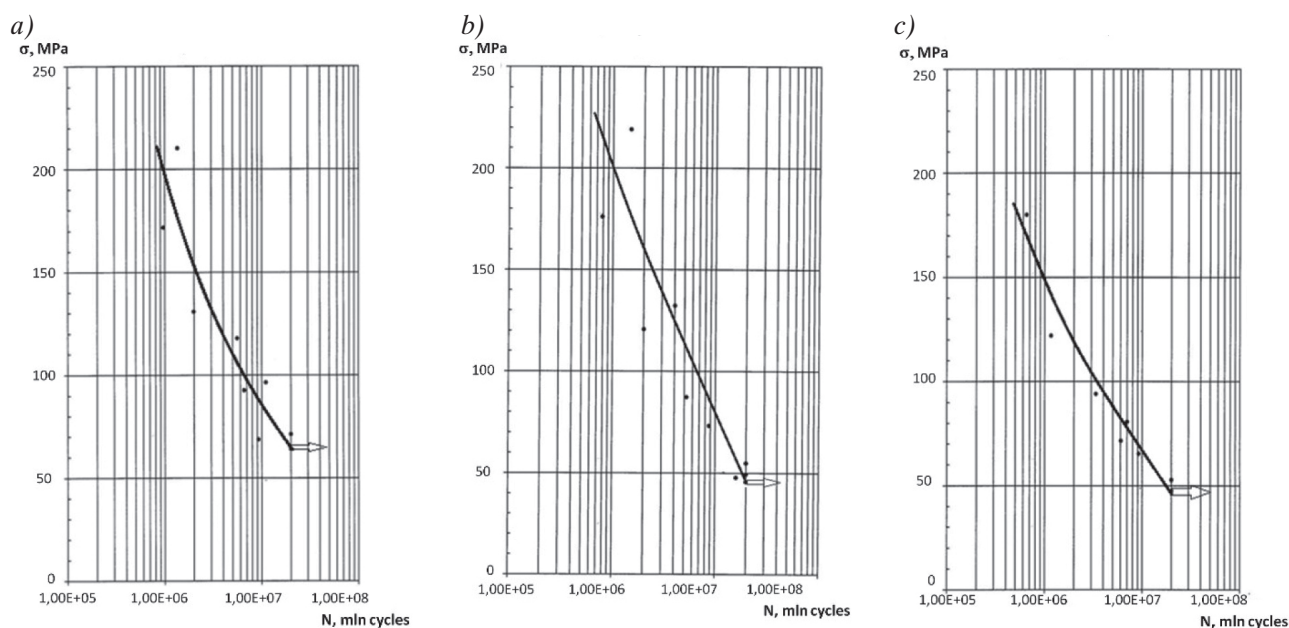
Fig. 2. Corrosion fatigue curve of sucker rod samples with a diameter of 19 mm from steel:  
a) 15H2GMF when tested in distilled water; b) 15H2GMF when tested in 3% aqueous NaCl solution;  
c) 15H2GMF when tested in formation water

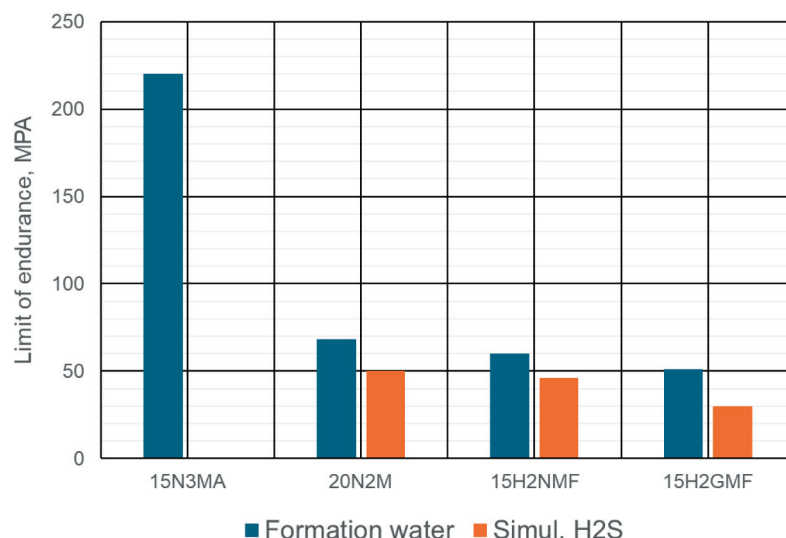
Fig. 3. Comparison of fatigue strength under alternating bending rotating samples from sucker rods with a diameter of 19 mm at loading frequency 15.8 Hz in corrosive environments

The results of full-scale corrosion fatigue tests of samples made from sucker rods of steel 15H2GMF (Tabs. 2 and 3, Fig. 3) show: the limited endurance limit of the tested rods in formation water is 22% lower than that of 20N2M steel and 13% lower than that of 15H2NMF steel; the limited endurance limit of the tested rods in an environment simulating the action of H<sub>2</sub>S

is 34% lower than that of 20N2M steel and 32% lower than that of 15H2NMF steel; the tested rods made of steel 15H2GMF are not recommended without hardening (surface plastic deformation) and appropriate protection (coating with anti-corrosion varnishes, enamels, the use of corrosion inhibitors) for corrosive operating conditions containing hydrogen sulfide.

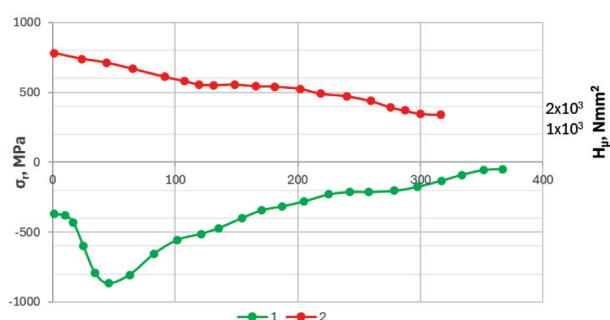
Fig. 4. Distribution of residual compressive stresses  $\sigma_r$  (1) and microhardness  $H_\mu$  (2) in 19-millimeter samples of new pump rods made of 20N2M steel after hardening

In addition, measurements were taken of the microhardness of the material of new hardened sucker rods that had worked in wells for 3 years. Microhardness measurements were carried out every 60  $\mu\text{m}$  from the surface to the center. The results of the measurements show that after three years of operation in the well, the microhardness in the sucker rod material decreases and levels out along the depth of the rod. A decrease in the microhardness of the sucker rod material subsequently gives rise to the initiation of microcracks, which also affects the decrease in corrosion-fatigue strength [5]. Thus, the residual compressive stresses that formed during the process of complex surface hardening decrease over time of operation under the combined action of a corrosive environment and prolonged cyclic loads. This leads to a decrease in resistance to corrosion-fatigue failure. However, for 3 years, 100% protection of the rod body from environmental influences is provided. Recently, new composite materials [12–17] have started to be used for the production of sucker rods, such as carbon fiber and hybrids (a carbon fiber core and a fiberglass shell), which have very high resistance to the action of corrosion.

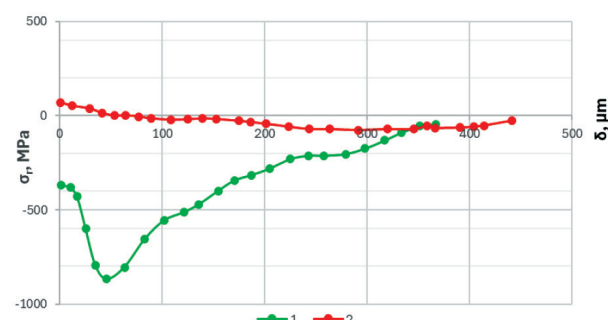
Fig. 5. Distribution of residual stresses in the surface layers of pump rods after the complex strengthening method (1) and their 3-year operation (2)

As is known, corrosion-fatigue strength largely depends on residual compressive stresses [2]; therefore, to explain the decrease in corrosion-fatigue strength, studies were carried out to determine the residual compressive stresses in the material of a sucker rod sample that had worked in a well for 3 years. As the research results show (Figs. 4 and 5), after three years of operation in the well, relaxation of residual compressive stresses occurs, it is especially noticeable in the upper layers of the metal, and therefore there is a noticeable decrease in corrosion-fatigue strength.
